# A summary and analysis of bridge failures

Maynard Horace Tweed  
*Iowa State University*

A Thesis Submitted to the  
Graduate Faculty in Partial Fulfillment of  
The Requirements for the Degree of  
MASTER OF SCIENCE

Major Subject: Structural Engineering

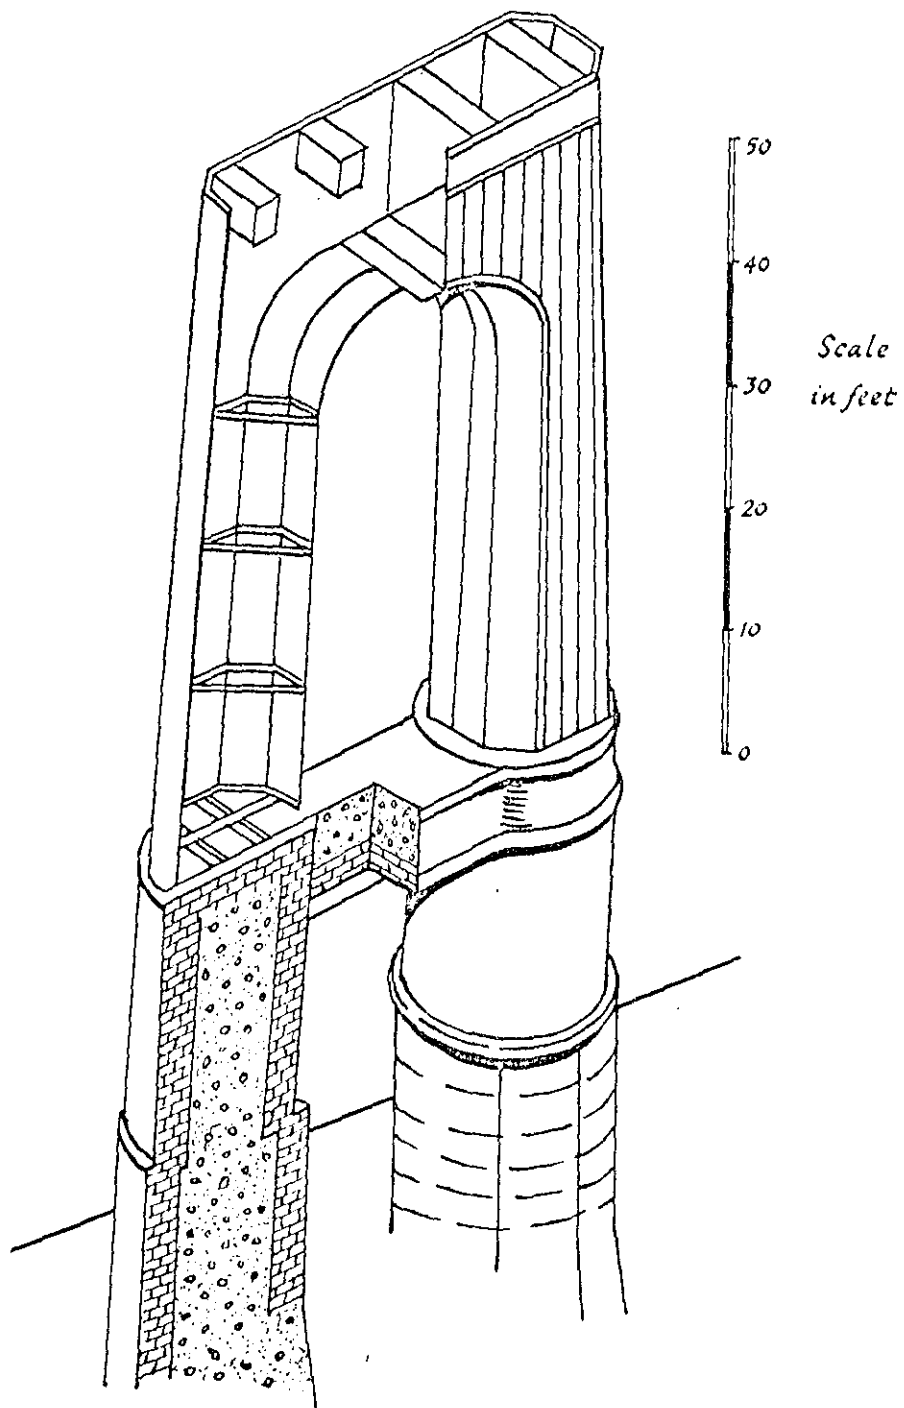
Figure 5. Pier of rebuilt Tay Bridge (99)

The lessons learned in the Tay Bridge disaster were remembered when the Forth Bridge was designed a few years later and the Tay Bridge was also rebuilt. The use of cast-iron was not considered in the rebuilding of the Tay Bridge nor in the Forth Bridge. The piers of the new Tay Bridge were built as shown in Figure 5.

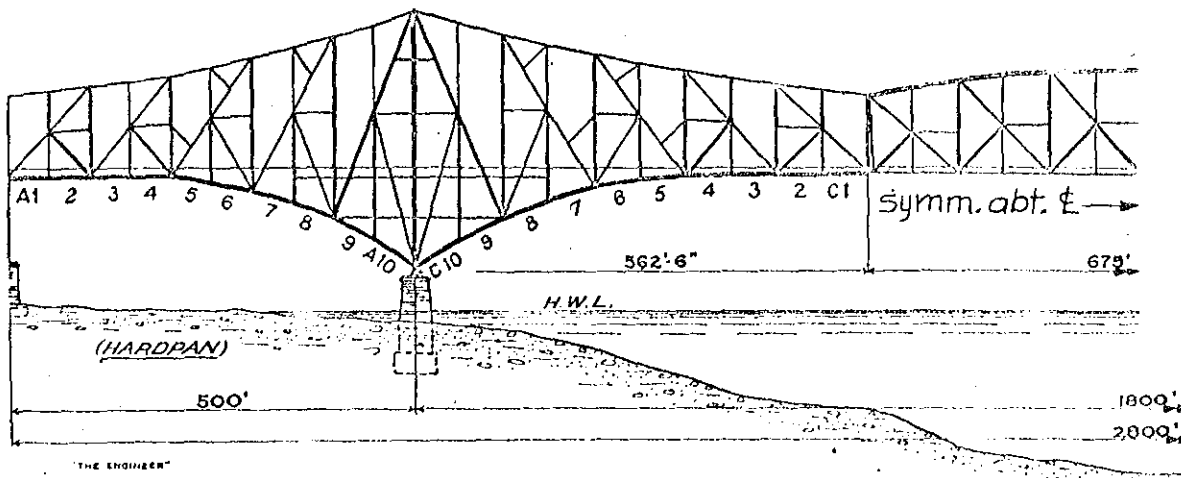
Figure 6. Final design of First Quebec Bridge (69)

type with a suspended center portion (see Figure 6).

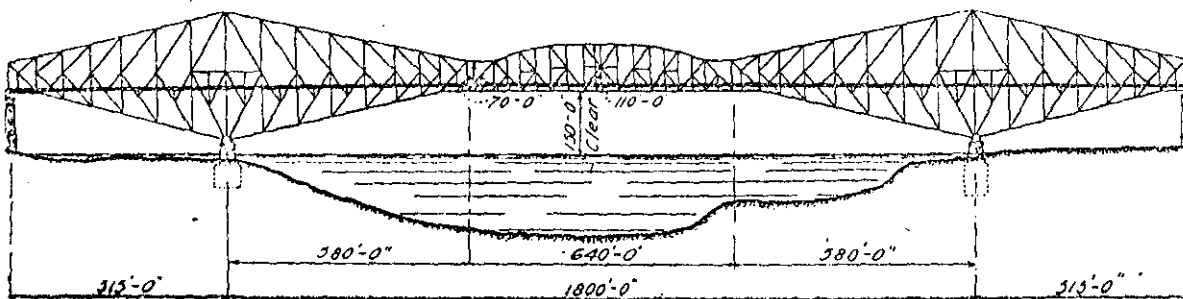
Figure 9. The Second Quebec Bridge, as built (69)

One of the most dramatic bridge failures was the failure of the Second Quebec Bridge on September 12, 1916 (3, 11, 12, 22, 38, 97). It is believed that only 13 lives were lost in this accident. The failure consisted of the center suspended span (see Figure 9 shown on page 54) falling into the St. Lawrence River during its hoisting operation.

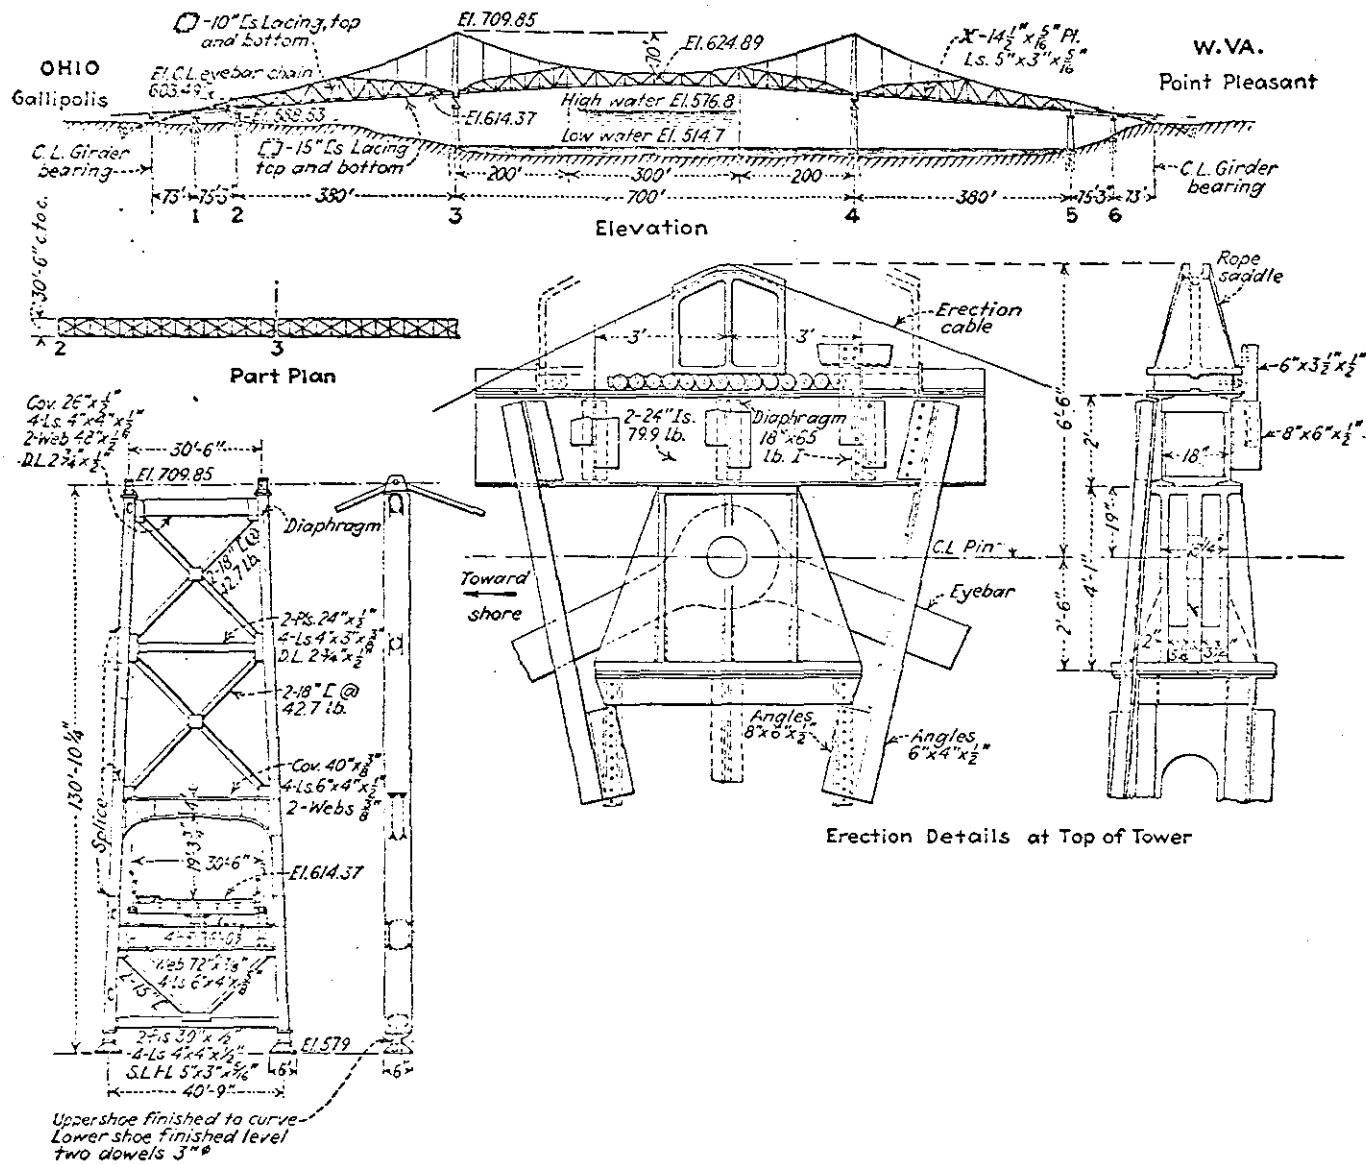
Figure 20. Details of Point Pleasant Bridge (49)

The make-up of the stiffening truss can be seen in Figure 20 and were of the laced channel type. The fact that there was no allowance for any adjustments to be made when erection was complete was an interesting feature. The last panel to be placed, which was the panel at the center of the bridge, could not be fabricated until final measurements could be made. The only error to be found was 5/16 in. in placing of the anchor bolts which was very remarkable.

The eyebar chains were erected by use of a traveler supported by an erection cable as shown in Figure 20. The cables were adjusted to a sag of 46 ft. in the main span under no load and a temperature of 68° F. With any other temperature the necessary adjustments had to be made. Erection of the eyebars proceeded from the center of the main span toward the tower and at the same time from the cable bents toward the towers, with the final link placed at the tower. This was done to maintain balance throughout the bridge.

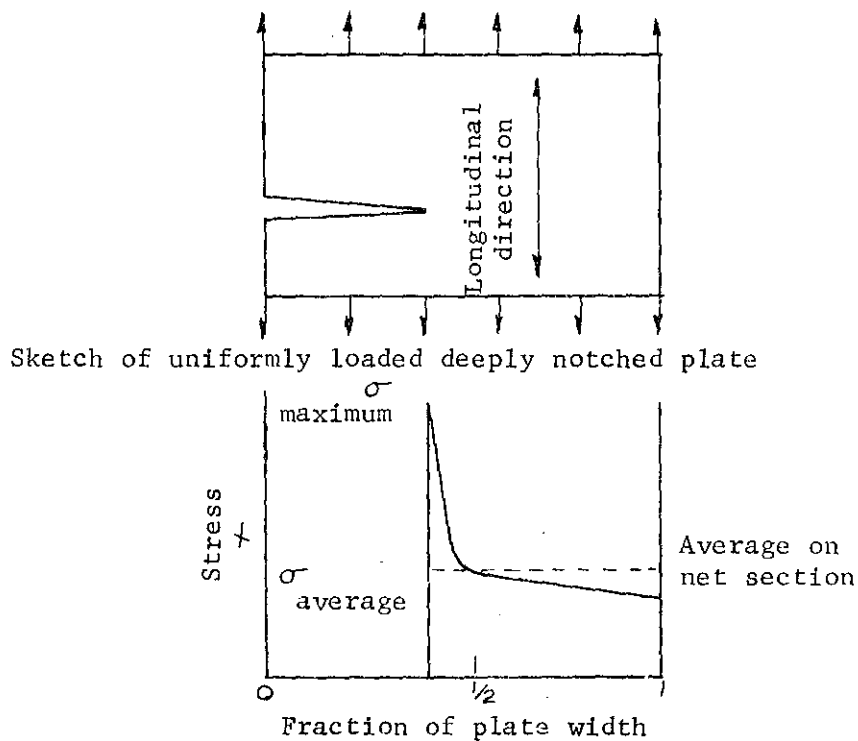
Figure 22. Diagram of notched plate showing longitudinal stress distribution (111)

An explanation of the effects of notches on brittle steel may be useful to the reader. When a tensile stress is applied to a plate without any notches the stress is uniform across the width of the plate. When a notch is present as shown in Figure 22 a high stress is concentrated at the apex of the notch and drops instantly to zero. Experiments show

that thicker plates with notches will fracture at lower temperatures than the thinner plates when under the same stress conditions. This is because in the thicker plate, once a crack starts to form at the apex of the notch there is a component of much higher stress in the thickness direction of the plate. At the same time the longitudinal tensile stress concentration factor is the same in the thicker plate as in the thinner plate. The reason for the component of higher stress in the thicker plate is due to the fact that the stress can reach a higher point before it begins to decrease and reaches zero at the edge (see Figure 23). The variation in the stress component along the width is also shown. The stress concentration at the apex of a notch is quite unfavorable and becomes more so with an increase in plate thickness and sharpness of notch.

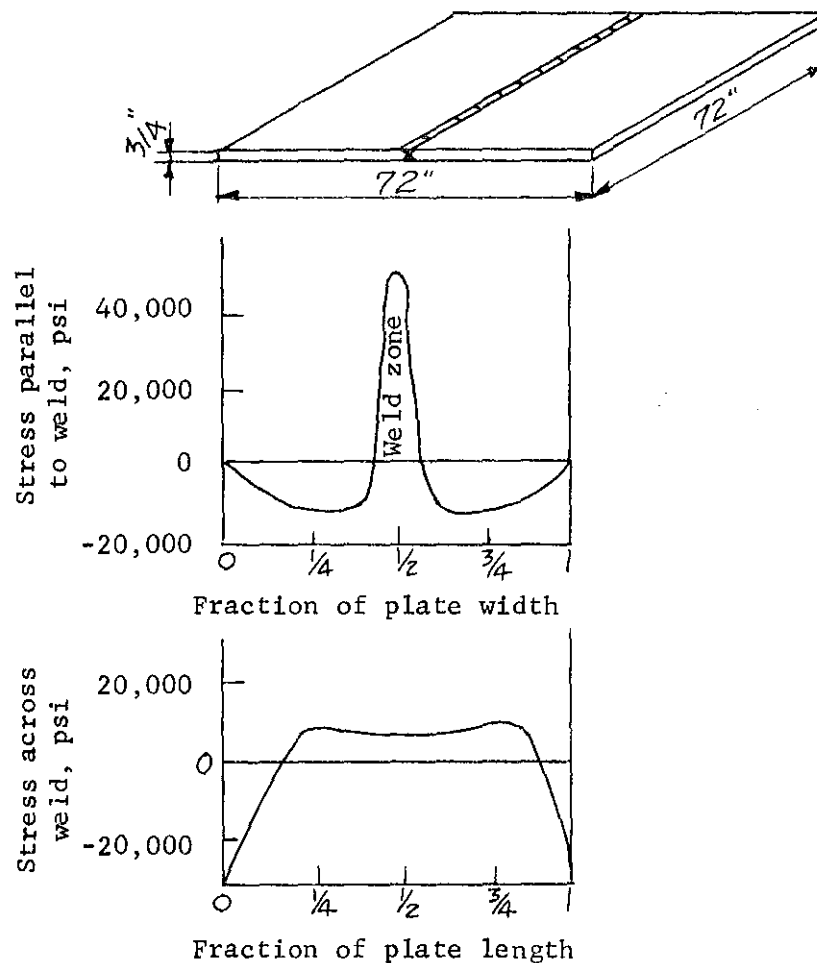
Figure 24. Diagram of butt welded steel plate and typical residual stress pattern (111)

somewhat more serious. In fact the residual stress may be as high as the yield strength of the metal. Patterns of these two types of residual stress problems are shown in Figure 24.

Residual stresses may be relieved by two methods. One method is by thermal means and the other is by mechanical means. The thermal method consists of heating the welded assembly to 1100-1200° F and holding that

temperature for two or three hours, then cooling very slowly. The residual stresses within the metal are relieved by plastic flow or creep with a uniform stress being obtained through the heated area. Also by this heat treatment the more brittle steel in the weld region is toughened by an alteration of the microstructure produced by exposure to very high temperature. Mechanical stress relieving is done by stretching plastically the regions containing tension stresses caused initially by shortening.

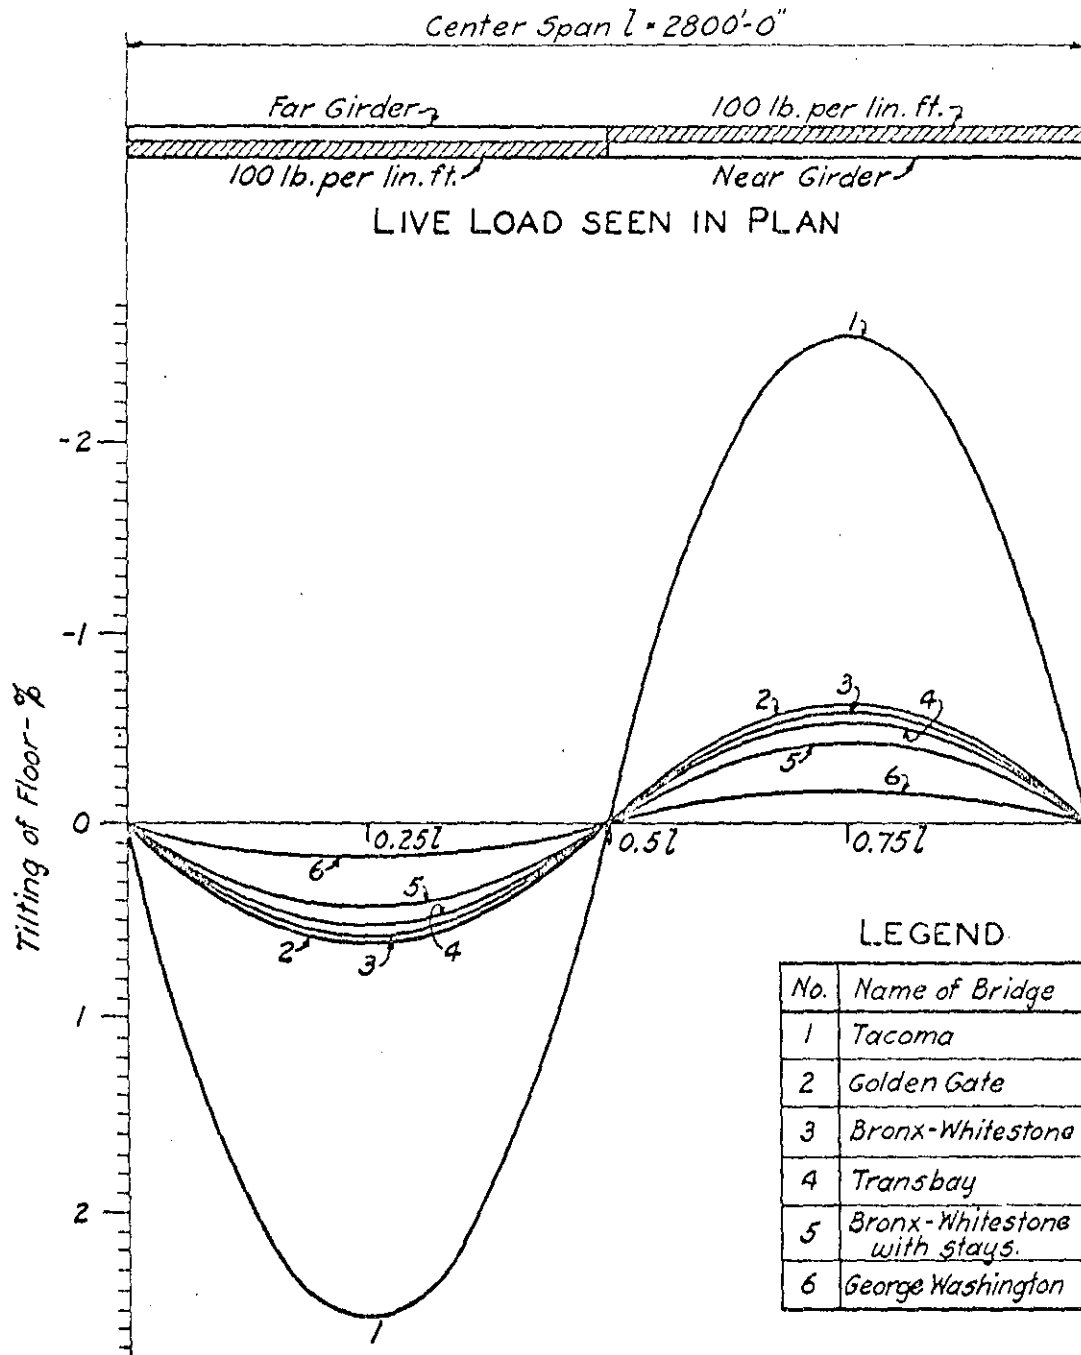
Figure 31. Comparative tilting of floor of the five longest suspension bridges (56)

in other bridges which were studied. See Figure 31 for comparative tilting of the floors.

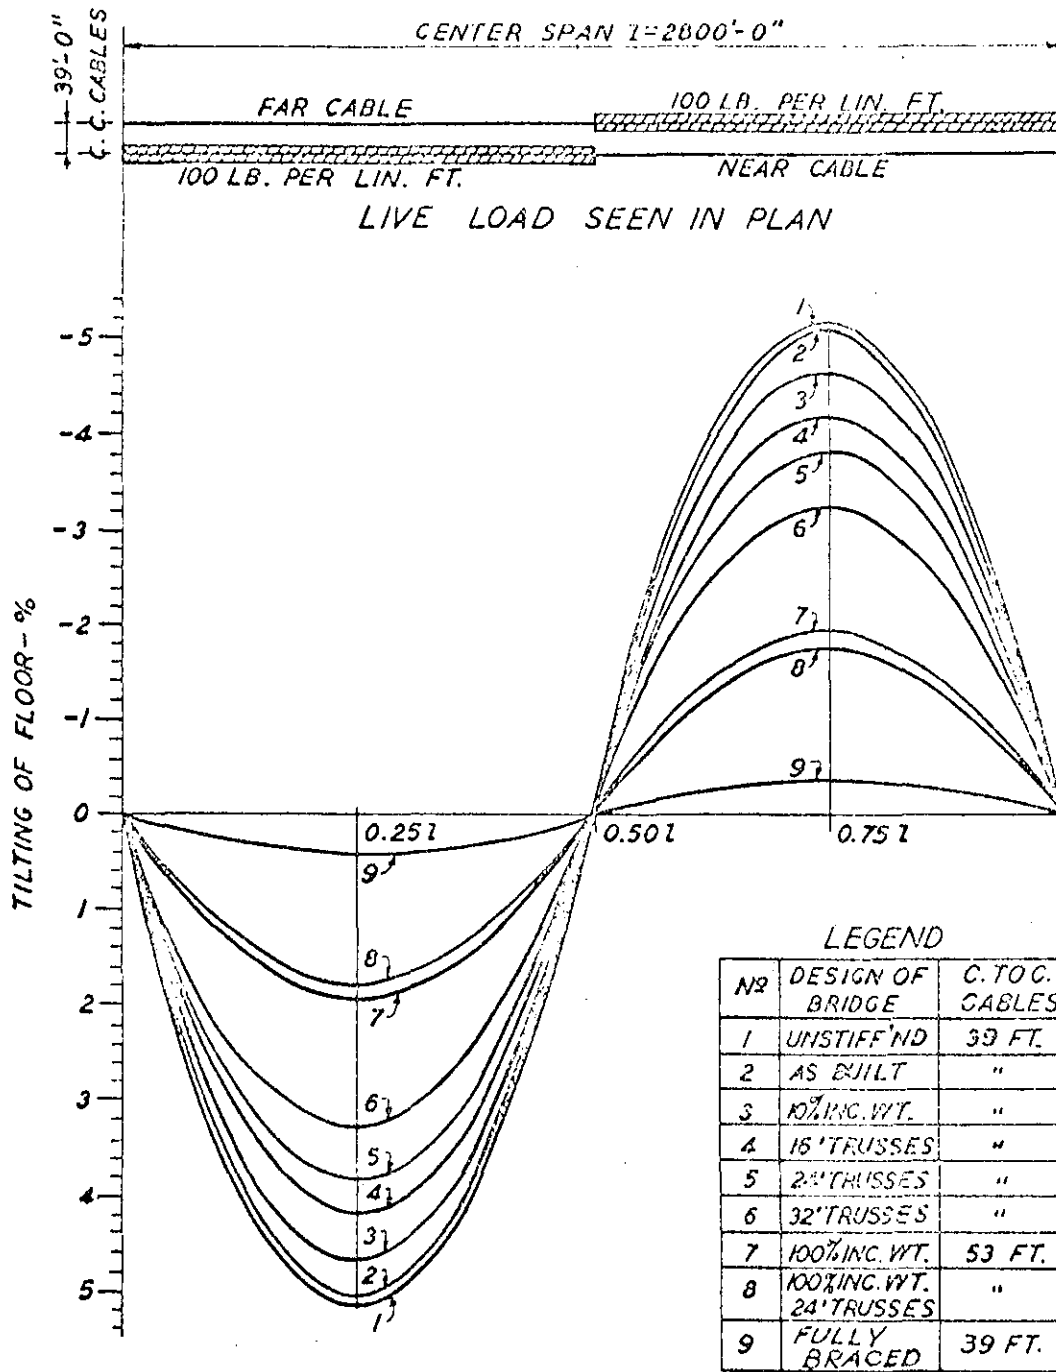
Figure 33. Comparative torsional deformations of nine Tacoma Bridge designs (56)

Torsional resistance which is very critical in the design of suspension bridges can be increased by: an increase in weight of the span, decreasing the cable sag, increasing the moment of inertia of the stiffening trusses, and increasing the width. The effects of these are shown in Figure 33. Comparison No. 9 gives the most resistance to torsion which is accounted for by its being fully braced. The fully braced design consisted of an open grid deck instead of concrete as used in the as-built bridge. It is interesting to note the great increase in No. 8 with the width increased to 53 ft. and 100 per cent more weight.

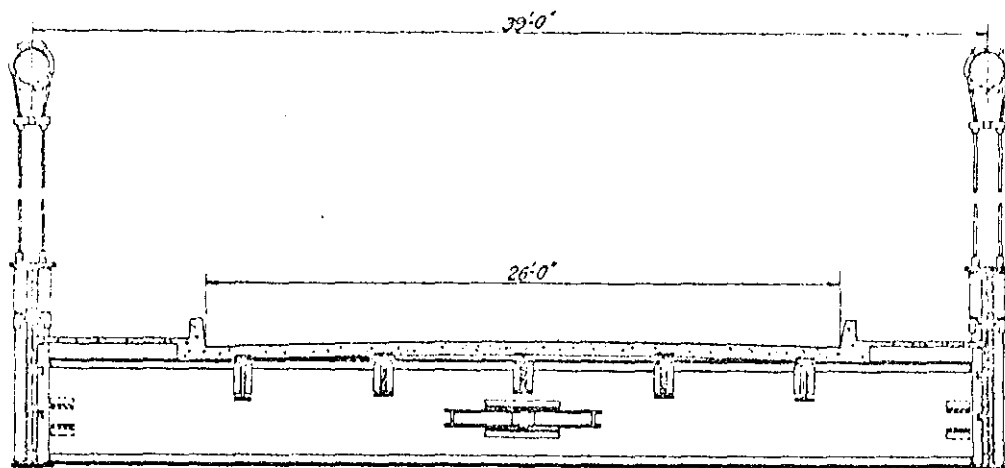
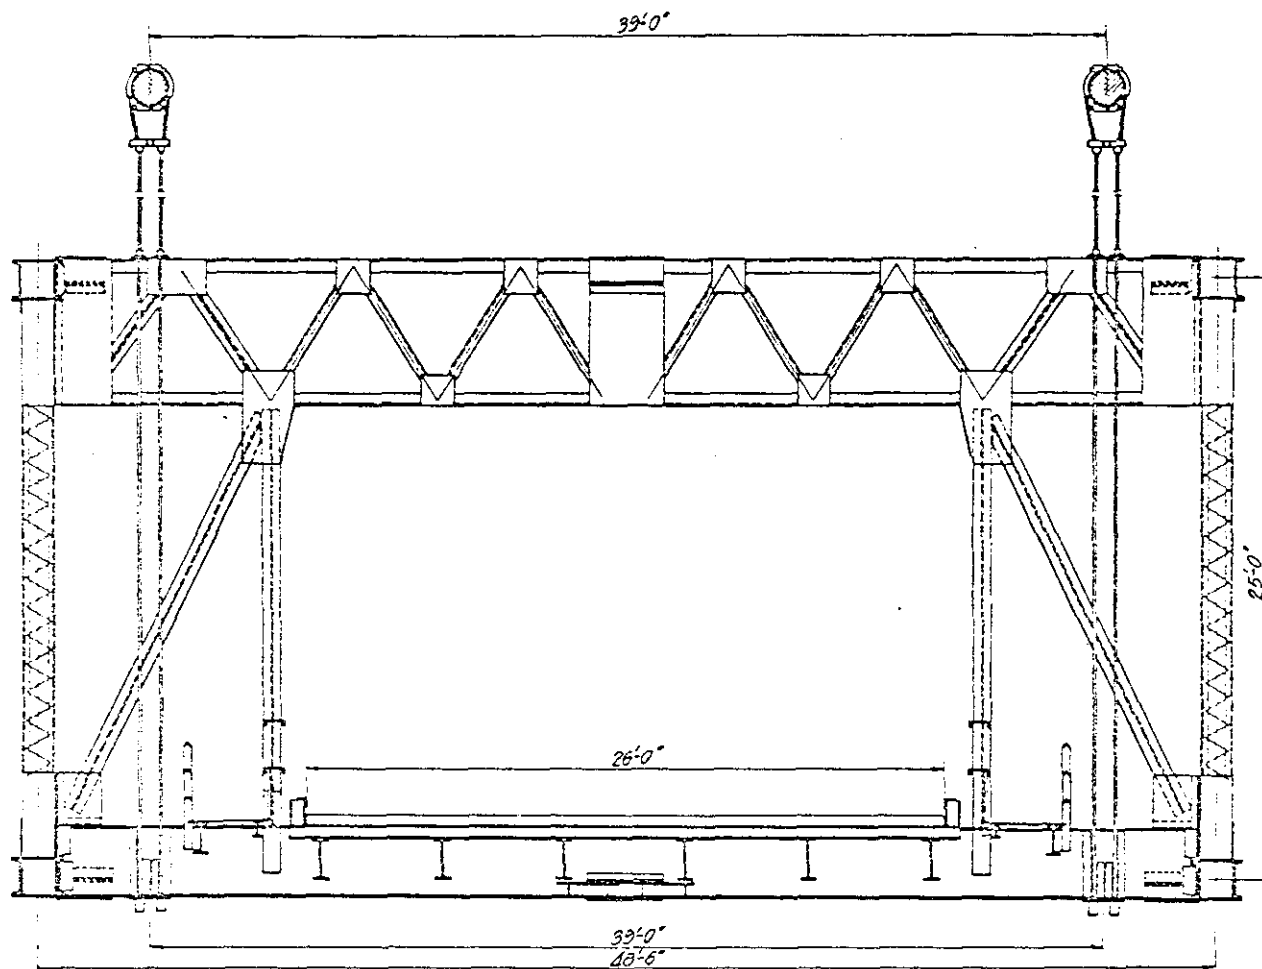
By use of the second type of loading the results were as shown in Table 5 with the tilting of the Tacoma Bridge being 10.8 times that of the George Washington Bridge. Also compared is the Tacoma Bridge with a cross-section as built and a cross-section fully braced (see Figures 34 and 35).

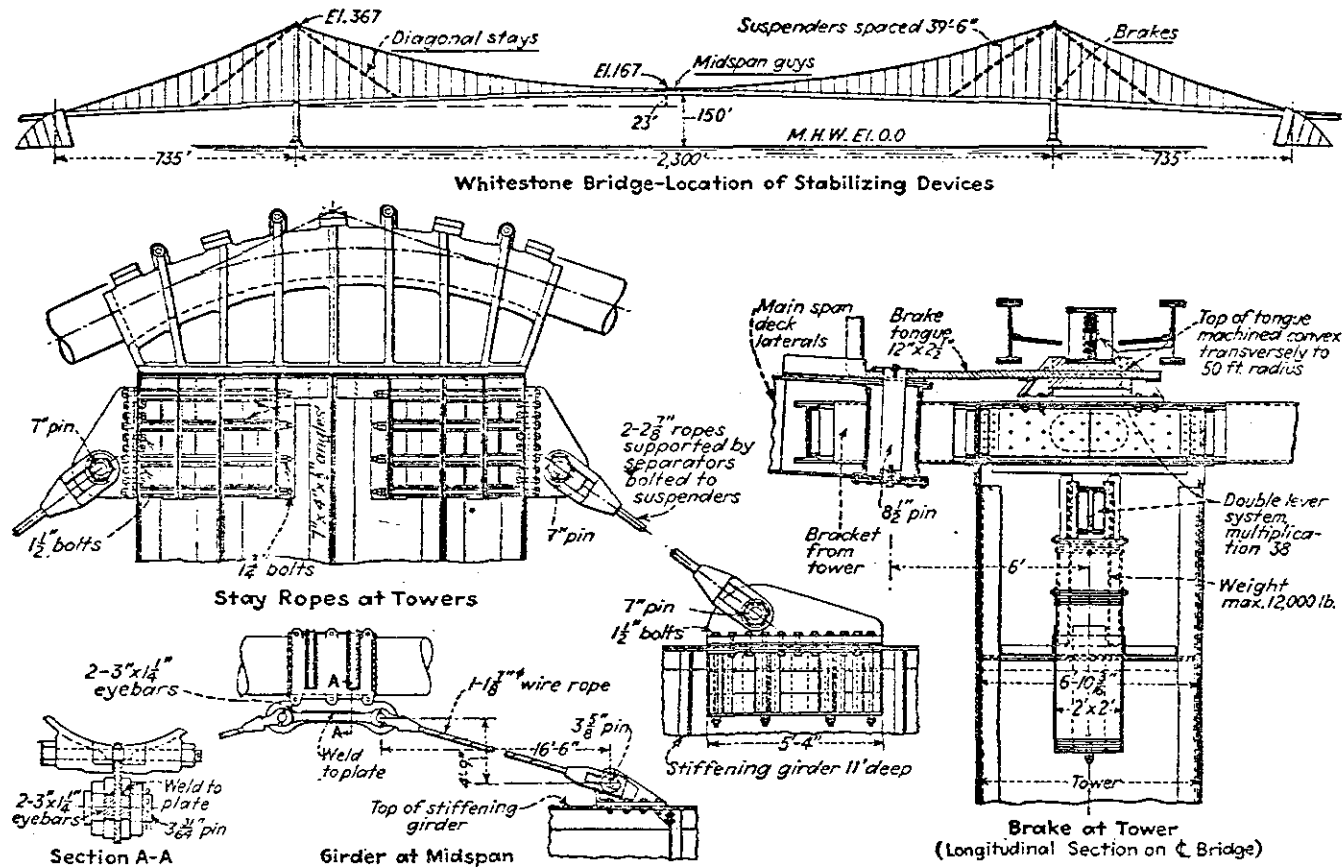
Figure 36. Damping installations on the Bronx-Whitestone Bridge (56)

The Bronx-Whitestone Bridge was subjected to wind forces which caused oscillation of large amounts but was corrected by damping installations as shown in Figure 36. Double amplitudes of 24 in. had been observed with the most severe motion when the wind was at an angle less than  $45^{\circ}$  to the longitudinal axis of the bridge. The most severe motion also occurred when a single node was at the center of the bridge span. The bridge was more stable when exposed to winds of higher velocities. The weight of the bridge was the contributing factor in stability of the Bronx-Whitestone Bridge.

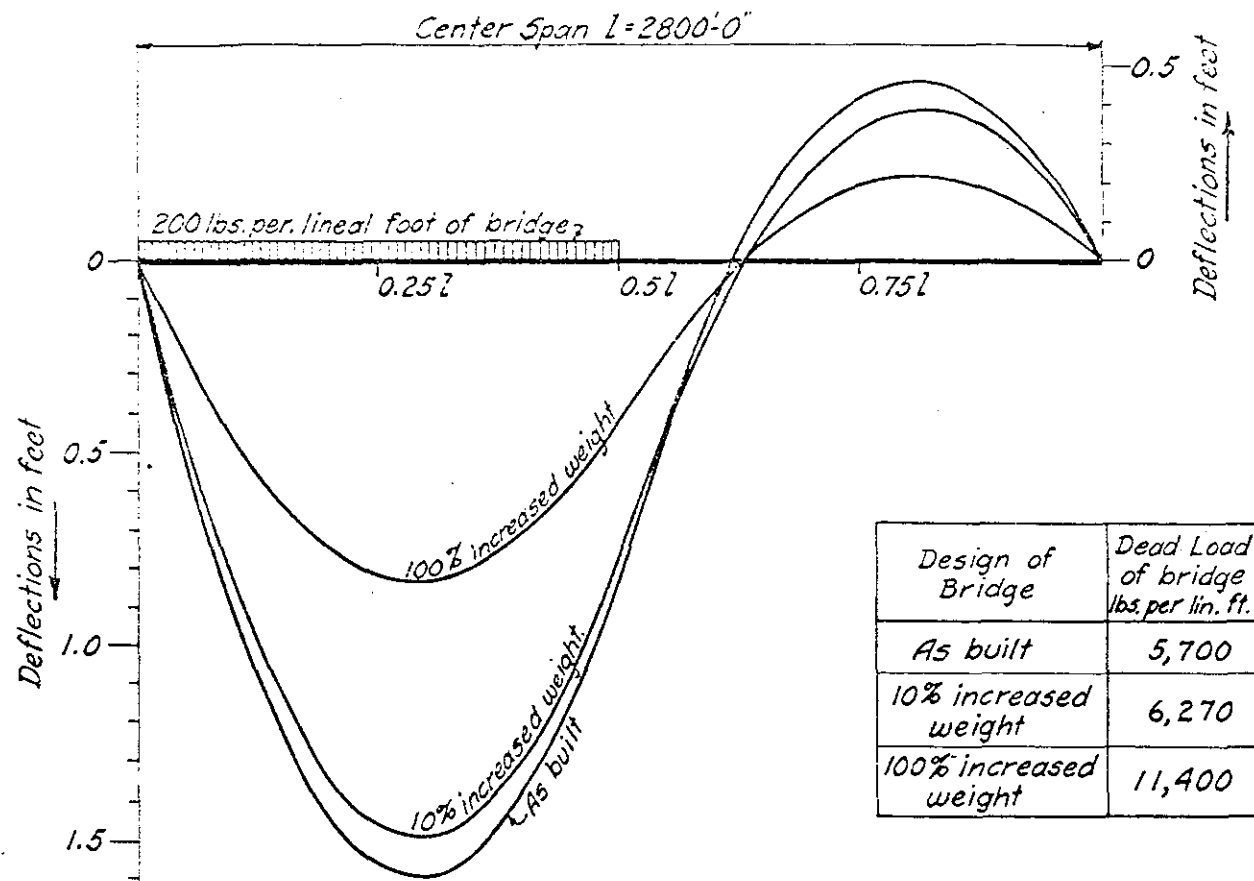
Figure 37. Effect of weight on comparative vertical deflections of the Tacoma Narrows Bridge (56)

The weight of the Tacoma Narrows Bridge was 6,270 lb per ft. An increase of 10 per cent by adding 2 in. to the thickness of the roadway slab would decrease the quarter point deflection by only about 5 per cent as seen in Figure 37. Increasing the weight by 100 per cent which could

be accomplished by doubling the traffic capacity, would decrease the static deflection near the quarter point from 1.59 ft. to 0.83 ft. which is a 48 per cent decrease. To make the bridge with rigidity like the Golden Gate and the Bronx-Whitestone the weight would have to be made  $2\frac{1}{2}$  times greater with the other proportions remaining the same.

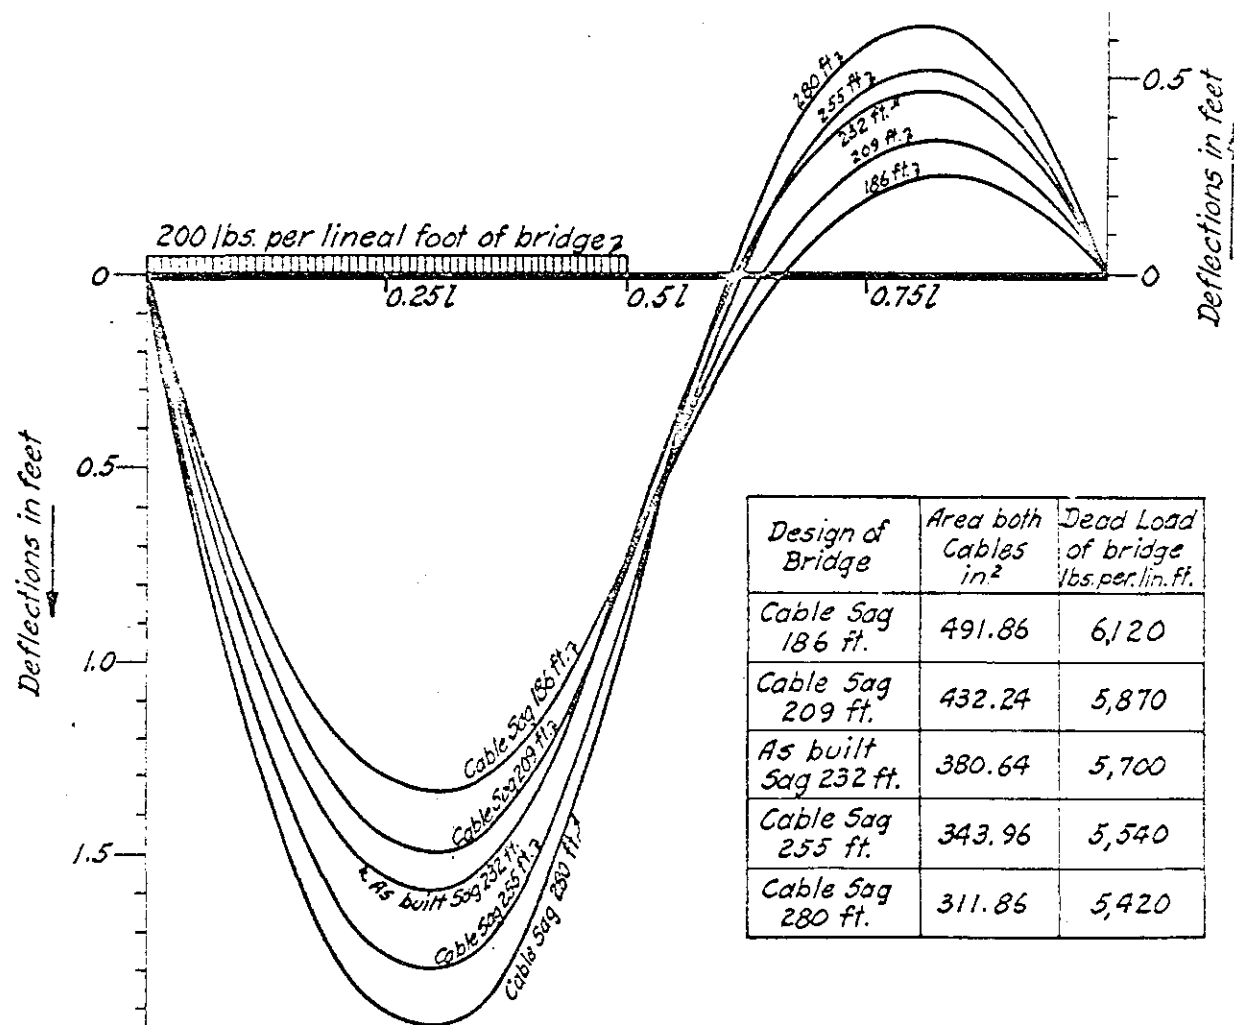
Figure 38. Effect of cable sag on comparative vertical deflections of the Tacoma Narrows Bridge (56)

The cable sag of the Tacoma Narrows Bridge was 232 ft. giving a ratio of cable sag to span of 1:12. A decrease of 10 per cent or a sag of 209 ft. would decrease the deflection at the quarter point from 1.59 to 1.49 which is only 6.3 per cent. This could not supply the necessary rigidity alone. The effect of cable sag on deflection is shown in Figure 38.

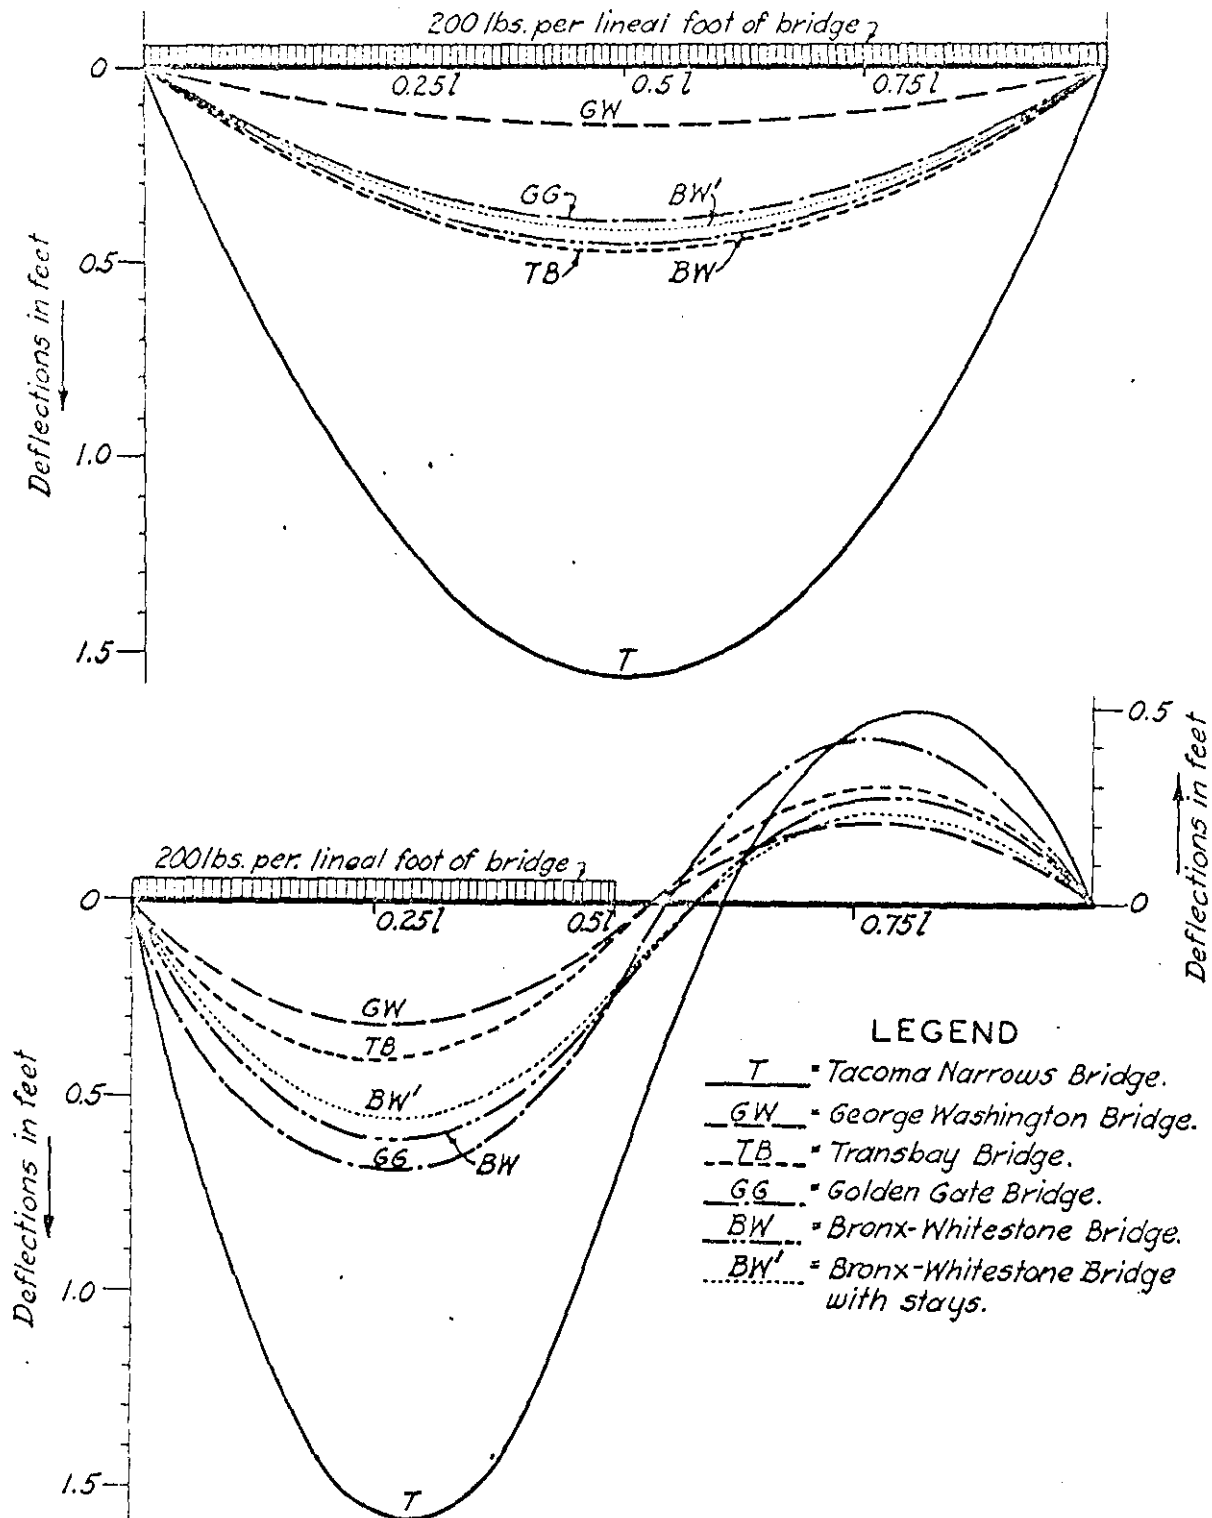
Figure 39. Comparative vertical deflections of the five longest suspension bridges due to a load of 200 lbs. per lin. foot of bridge (56)

These same results can be seen graphically in Figure 39. It is apparent that the vertical deflection of the Tacoma Narrows Bridge was comparatively very large.

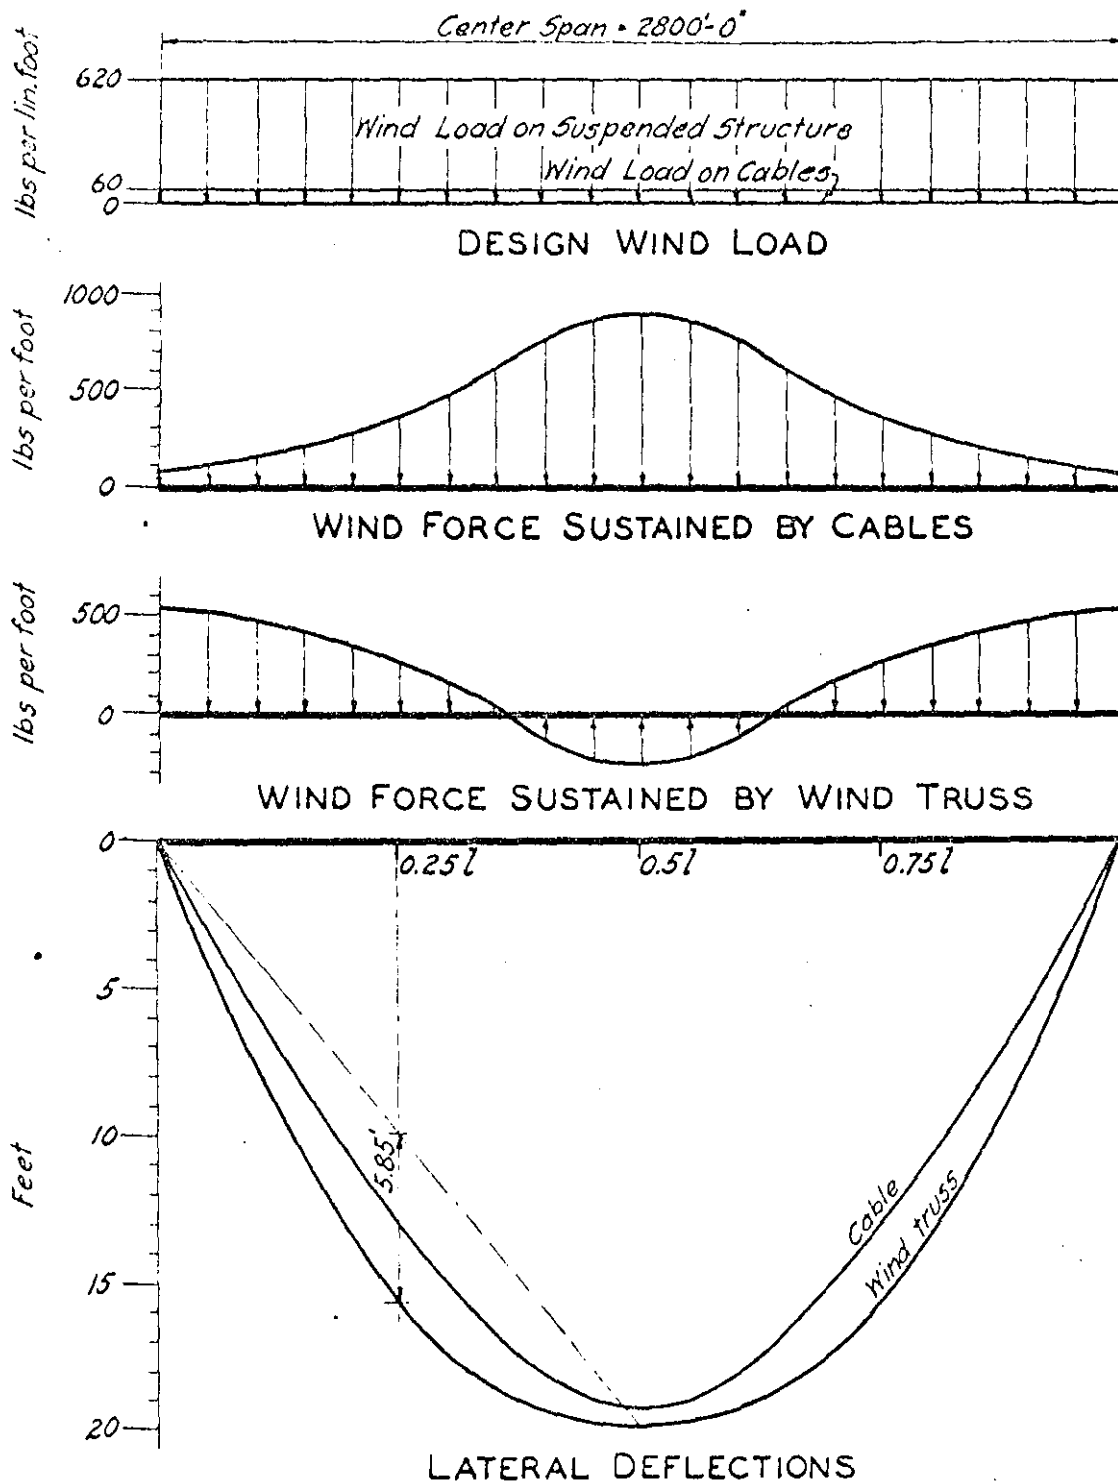
Figure 40. Distribution of 620 lbs. per lineal foot design wind load and resulting lateral deflections of the Tacoma Narrows Bridge (56)

The distribution of wind forces to the floor and cables for the Tacoma Narrows Bridge is shown in Figure 40 and illustrates the supporting effect of the cables on the wind truss. If the wind truss is relatively flexible in the transverse direction much of the wind force acting on the suspended structure is transmitted to the cables and then to the towers. Even the most flexible and narrow long span suspended bridges have a relatively small amount of lateral motion. The lateral stability and deflection are largely independent of the rigidity and width of the wind truss. The rigidity of the wind truss in the lateral direction is a more important factor in resisting torsion when the vertical rigidity is insufficient.
